TECHNICAL REPORT H-78-3

MODEL STUDIES OF THE PORTUGUES AND BUCANA RIVERS CHANNELIZATION PUERTO RICO

Hydraulic Model Investigation

Noel R. Oswalt

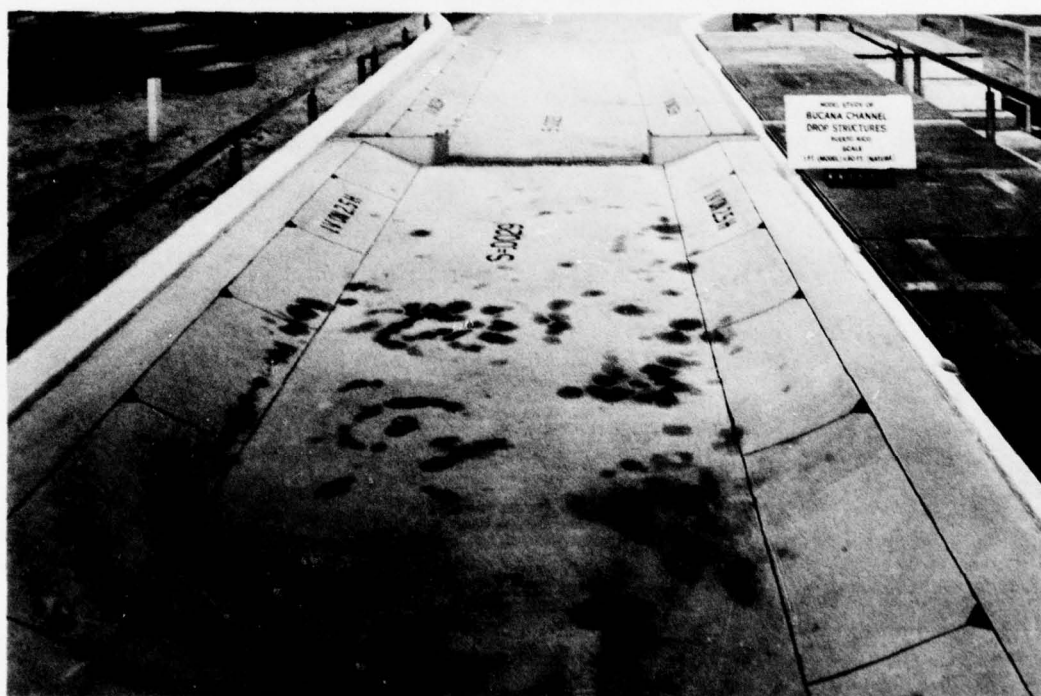
b. Drop structures

Figure 2. Bucana Channel test facility

8. The second model (Figure 2b) was also constructed to a 1:30 scale and reproduced about 1200 ft of the 150-ft-wide Bucana Channel for studying the drop structures and the adjacent riprap protection requirements (Plate 2). The trapezoidal sections of both models were molded in sand and cement mortar to sheet-metal templates initially to test the original structures within the channel. All transitions, stilling basins, rectangular channel sections, and drop structures were made of plastic-coated plywood and some sheet metal. Riprap replaced the cement mortar in later tests to determine the riprap protection requirements with the recommended structures. Filter cloth was placed between the sand and the graded riprap for all riprap tests. The gradations of riprap simulated and tested in the model compare with those based on Engineer Technical Letter 1110-2-120* for 165 lb/cu ft riprap placed in the dry with a $1.0 D_{100}$ maximum thickness.

12. Tests to determine the adequacy of the Bucana Channel drop structures 1-4 (Plate 2) were conducted in the facility shown in Plate 3 and Figure 2b. For expediency, the initial test channel was covered with grout in lieu of riprap. The channel riprap requirements were determined in later tests after the optimum drop structure design had been developed.

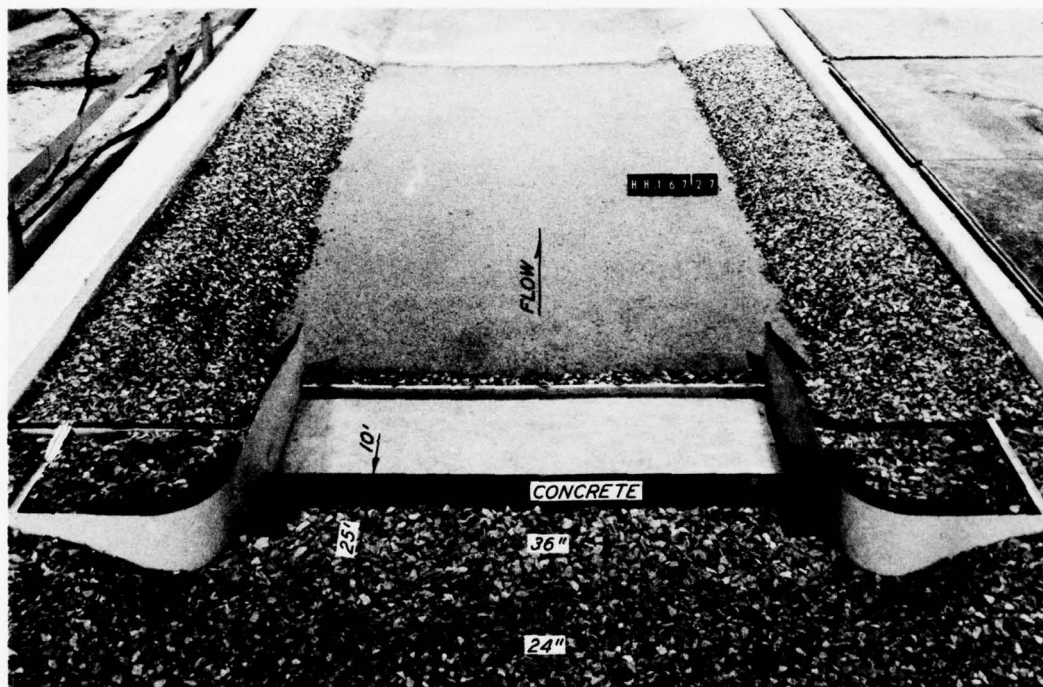
Figure 4. Drop structure 4, design 4, type 1 riprap plan (looking downstream)

20. Unfortunately, the design 4 structure increased hydraulic capacity and approach velocities relative to those with the original drop structure 4, and would require costly additional protection upstream (Figure 4). Therefore the original basin design was favored and recommended for the prototype.

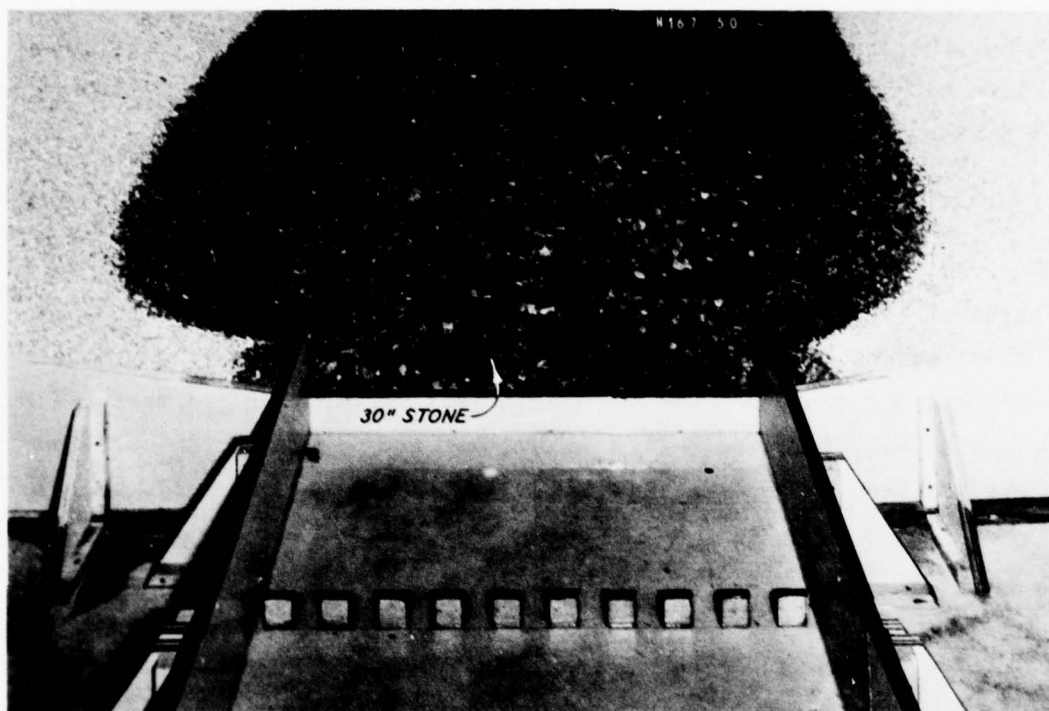
Figure 8. Dry bed of original stilling basin B-3 showing riprap damage after 1-hr (prototype) operation with design flow 22,700 cfs and tailwater el 129.5

31. Photo 19 of the original B-3 stilling basin was taken before operation of the model and Photo 20 was taken with the design flow 22,700 cfs. Velocities measured downstream from the basin are shown in Plate 33 and a water-surface profile is shown in Plate 34. The

water surface in the basin was approximately 3 ft higher than that expected and overtopped the basin walls. A drawdown of the water surface immediately downstream from the end sill resulted in failure of the 30-in. riprap as shown in Figure 8.

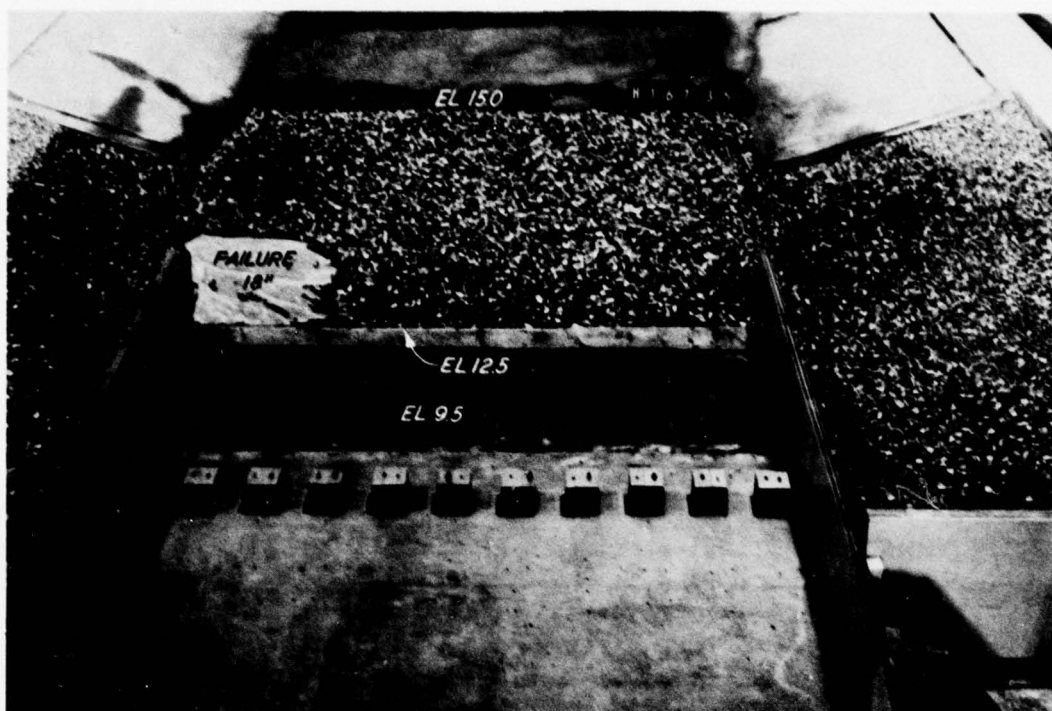
Figure 9. Failure of 18-in. riprap after 30-min (prototype) operation with design flow 28,900 cfs

36. Tests were conducted to determine the minimum riprap requirements downstream from Bucana stilling basin B-1 and upstream from the transition at sta 157+81. Initial tests were conducted with 18-in. riprap sloped up 1V on 25H to the natural channel invert. Failure of this riprap occurred with the design discharge as shown in Figure 9. The 18-in. riprap was replaced with 24-in. riprap, but again failure occurred with the design discharge. A 30-in. riprap blanket was required to remain stable on the 1V-on-25H upslope downstream of the recommended B-1 basin; however, a 24-in. riprap blanket was adequate protection when placed horizontally at el 11.5 downstream of the recommended basin design shown in Plate 43. This plan is recommended for prototype use. Photo 21 shows the model after 1-hr (prototype) operation with the design flow of 28,900 cfs and indicates that the 18-in. riprap on the side slopes and the 24-in. riprap on the invert will be stable although the natural channel bottom is likely to be scoured as was the model

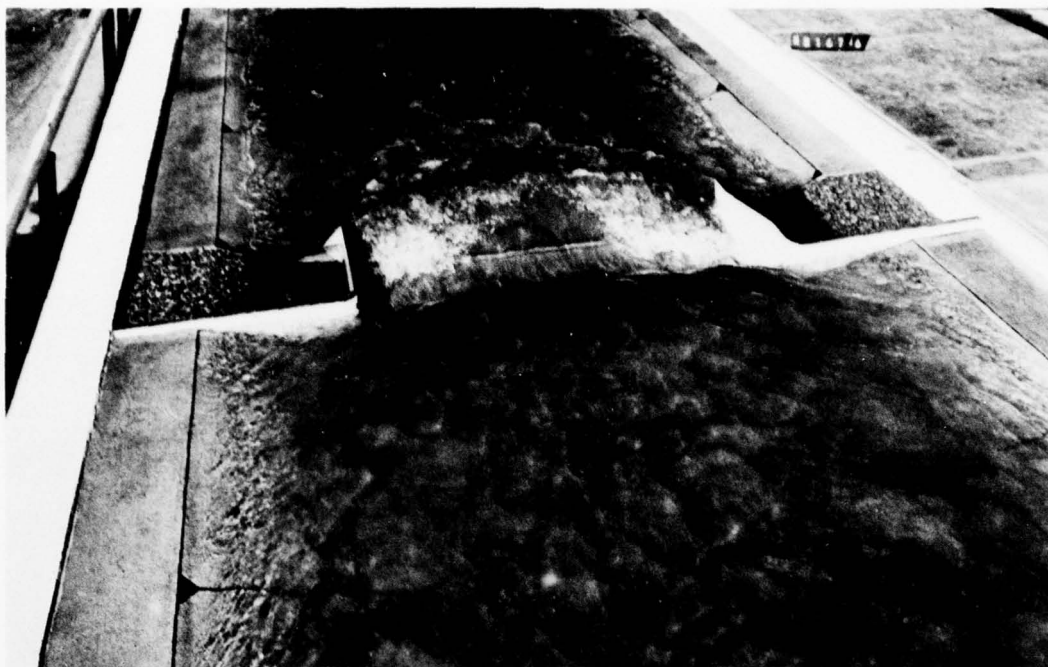
a. Tailwater el 81.2 (1.8 ft below rating curve); hydraulic jump is sweeping out of drop structure

b. Tailwater el 82.1 (0.9 ft below rating curve); forced hydraulic jump

Photo 3. Drop structure 1 (original design), design flow 27,800 cfs
(sheet 1 of 2)

c. Tailwater el 83.7 (0.7 ft above rating curve);
good hydraulic jump

d. Tailwater el 84.5 (1.6 ft above rating curve);
mild eddy on each side of drop structure

14. Performance curves obtained for drop structure 1 throughout the range of expected operation (Plate 7) indicated that the original design structure would provide a satisfactory drop in water surface without increasing downstream velocities or creating adverse flow patterns. Photographs of the flow conditions observed with the design flow of 27,800 cfs and a range of tailwaters beyond those expected are provided in Photo 3. Both upstream and downstream velocities for the original design are provided in Plates 8 and 9.

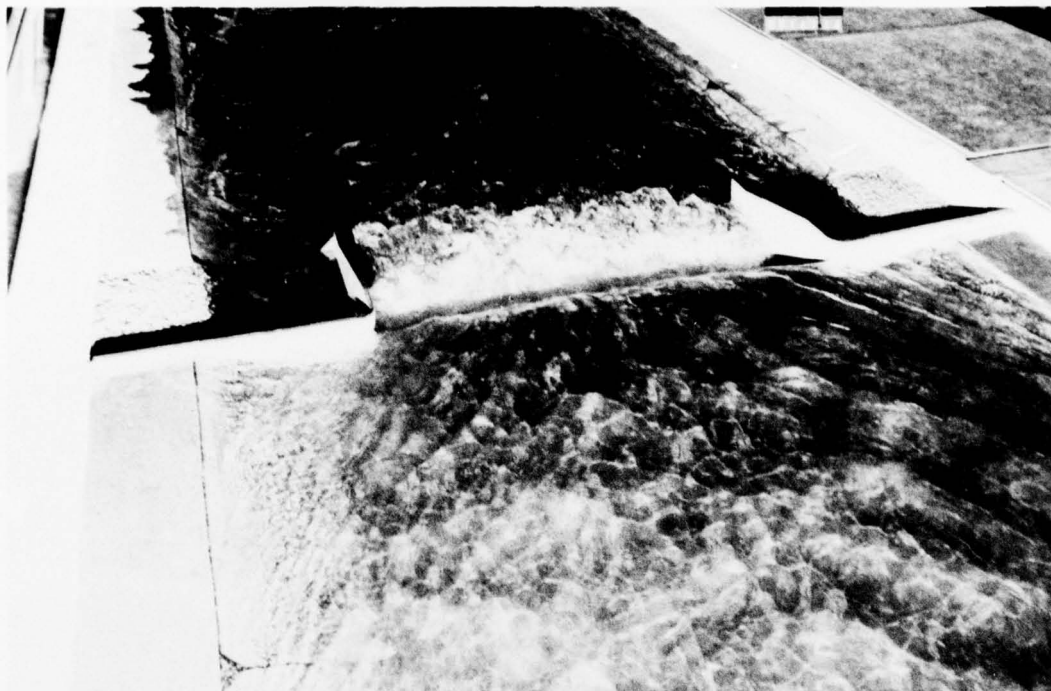
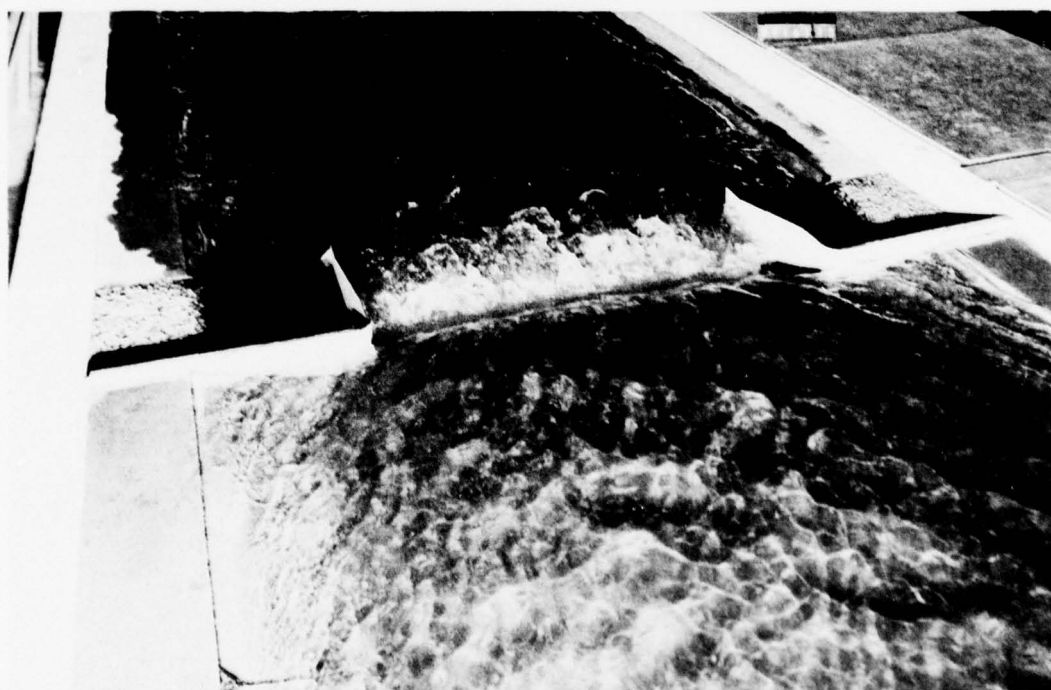
a. Tailwater el 103.2, forced jump

b. Tailwater el 104.5, good jump

Photo 5. Drop structure 3, design flow 24,700 cfs (sheet 1 of 2)

c. Tailwater el 108.6, submerged jump

17. Performance curves obtained throughout the expected range of operation (Plate 13) indicate that the original design structure 3 would provide a satisfactory drop in water surface without increasing downstream velocities or creating adverse flow patterns. Photos 5a, 5b, and 5c show flow conditions with the design flow of 24,700 cfs and tailwater elevations of 103.2 (forced jump), 104.5 (good jump), and 108.6 (submerged jump), respectively. A center-line water-surface profile and velocities measured 15 ft upstream and 75 ft downstream of the structure are provided in Plates 14 and 15. Based on the good performance obtained within the range of expected tailwaters, no modifications were recommended to the original design drop structure 3.

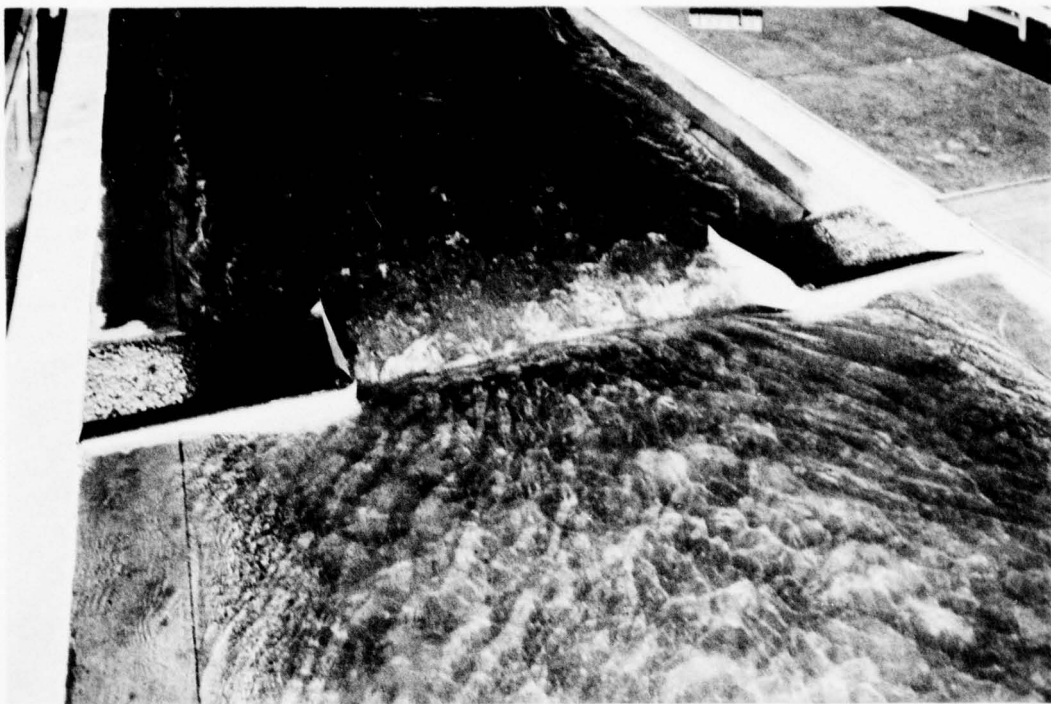
a. Tailwater el 116.8, good jump

b. Tailwater el, 119.2, eddies

Photo 6. Drop structure *b* (original design), design flow 24,700 cfs

18. Performance curves on drop structure 4 (Plate 16) for the full range of expected flows up to 24,700 cfs indicated that the original design would provide a satisfactory drop in water surface without creating a significant increase in downstream velocities. However, a mild eddy did develop with the normal tailwater and reduced velocities in each side of the drop structure. This intermittent eddy occurred on each side of drop structure 4 as sketched in Figure 3 with tailwaters 0.5 ft or more above the normal tailwater. This created reverse flow, reduced the effective width of drop structure, and created higher velocities in the remaining width of structure. Photographs of good and bad flow conditions with the original design and a discharge of 24,700 cfs are shown in Photo 6.

19. The eddies observed at tailwater elevations of 0.5 ft or more above normal with drop structure 4 (Photo 6b) were attributed to the abrupt approach walls and the related tailwater elevation. Therefore modifications to the original approach walls were tested to prevent occurrence of these eddies. Various semicircular, curved, and straight walls were tested. Design 4, shown in Plate 17, consists of a 35-ft upstream extension of the approach walls on each side with a 15-ft radius at the abutments. This design prevented the eddies and reduced the maximum downstream velocities. A comparison of the original design and design 4 velocities (Plate 18) shows the improved flow distribution and reduced velocities near the invert with design 4. Walls shorter than 35 ft were not as effective in improving flow conditions. Water-surface profiles of the original design and design 4 are shown in Plates 19 and 20, respectively. Photographs of flow conditions with

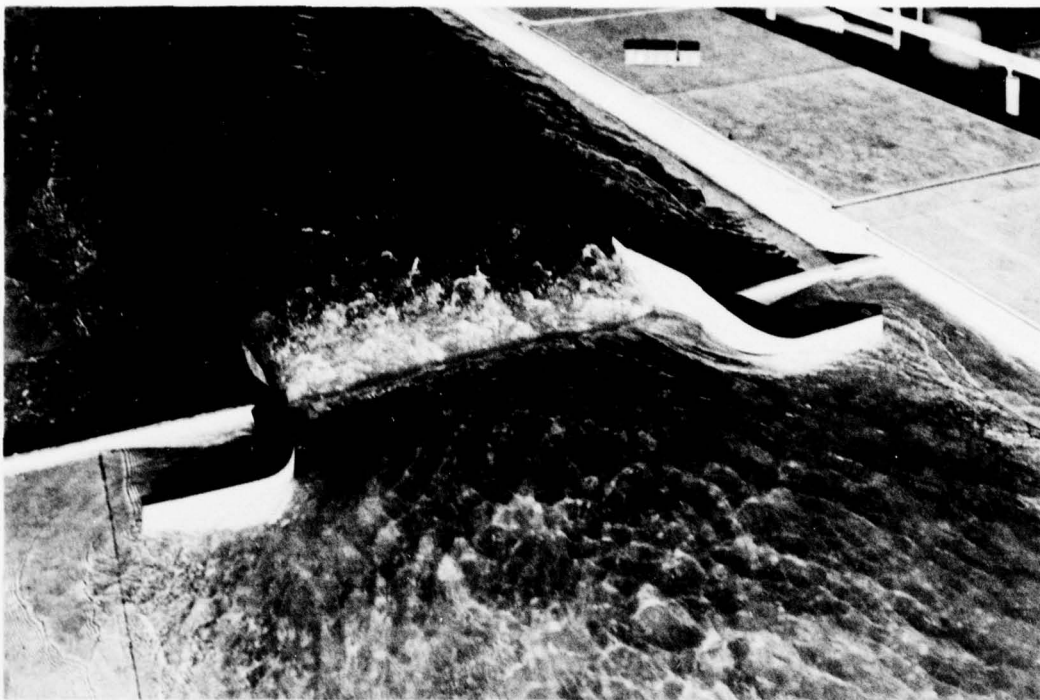
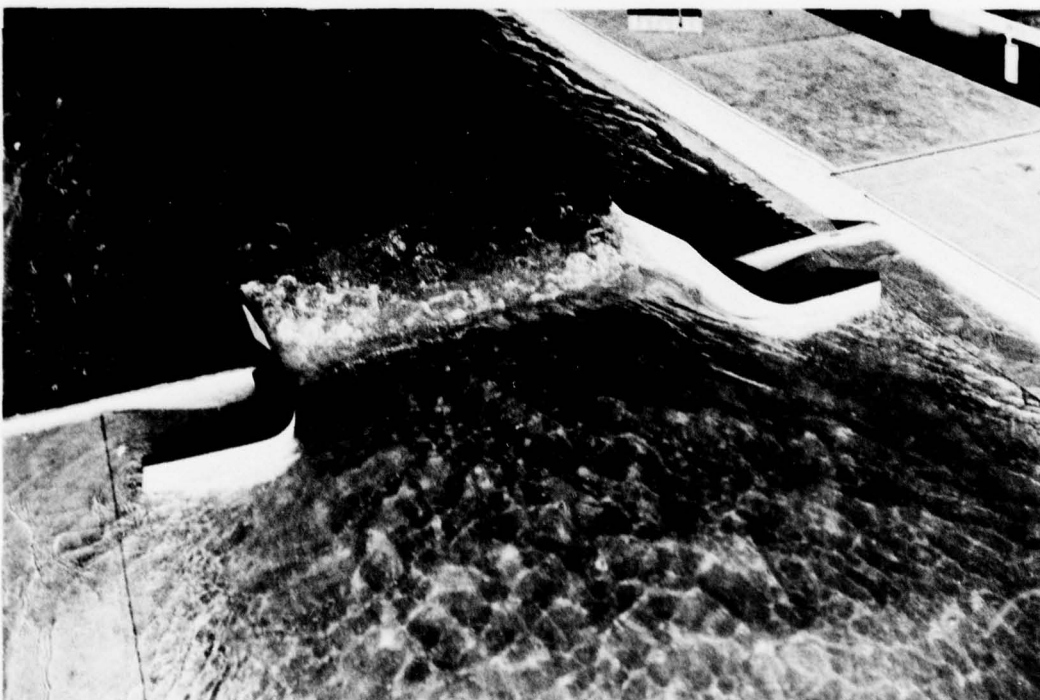
a. Tailwater el 116.8, good jump

b. Tailwater el 119.2, good jump

Photo 7. Drop structure 4 (design 4), design flow 24,700 cfs

design 4, a 24,700-cfs design flow, and tailwaters of 116.8 and 119.2 are shown in Photo 7.

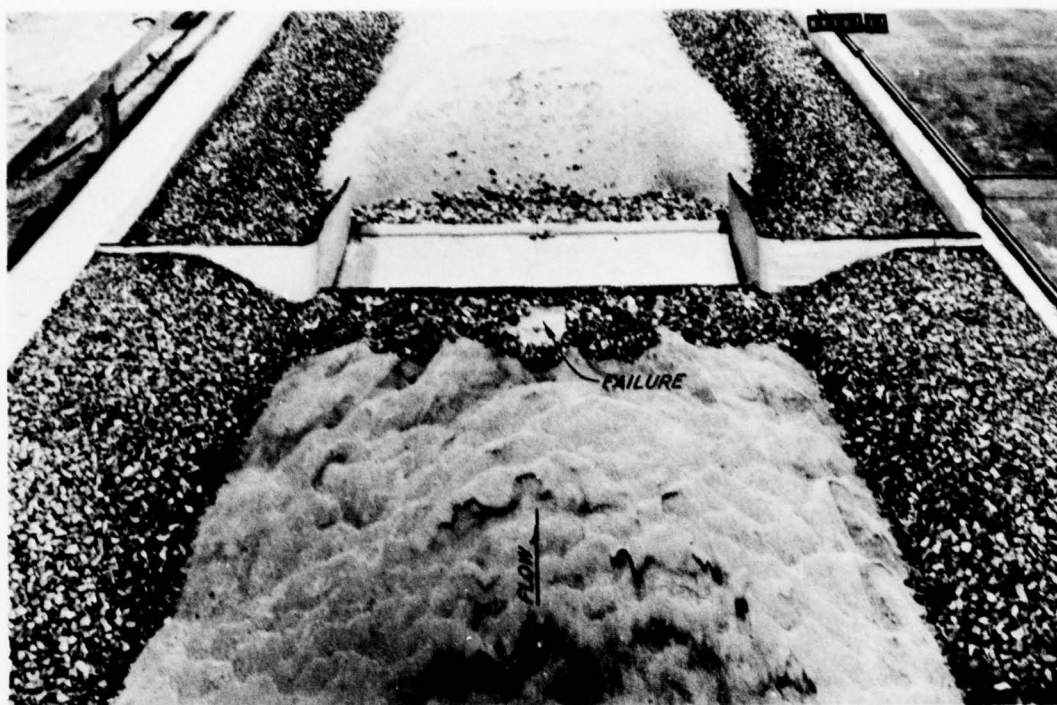
a. Looking downstream

b. Looking upstream

Photo 8. Drop structure 1 (original design); failure of type 8 riprap plan after 30-min (prototype) operation with 27,800-cfs flow

22. The type 8 riprap plan recommended for drop structures 2, 3, and 4 was not recommended for drop structure 1 because the 24-in. riprap upstream of the structure failed as shown in Photo 8. Any appreciable movement of riprap in model tests was considered failure. Some 36-in. riprap upstream of the structure moved after the 24-in. riprap had failed in a previous test; however, a 20-ft-long horizontal blanket of 36-in. riprap plan 10) of the structure was stable (Photo 9). Deposition of model sand and riprap downstream of the upper sill resulted after each test and indicated that maintenance will probably be required after the larger floods for all four drop structures. The deposition of sand and loose stone in the structure downstream of the upper sill (Figure 5)

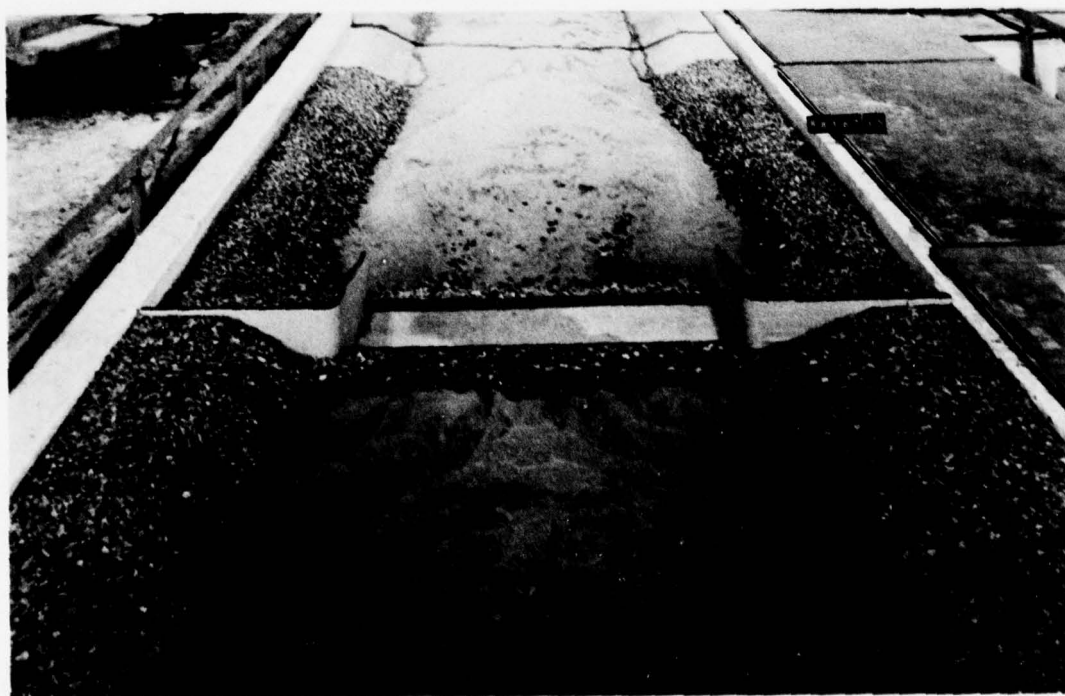
Photo 10. Drop structure 4 (design 4); type 8 riprap plan (recommended) after 1-hr (prototype) operation with 24,700-cfs flow

23. Photo 10 shows the recommended riprap design 8 for drop

structure 4 taken after the design flow. This condition is typical of that expected at drop structures 2, 3, and 4.

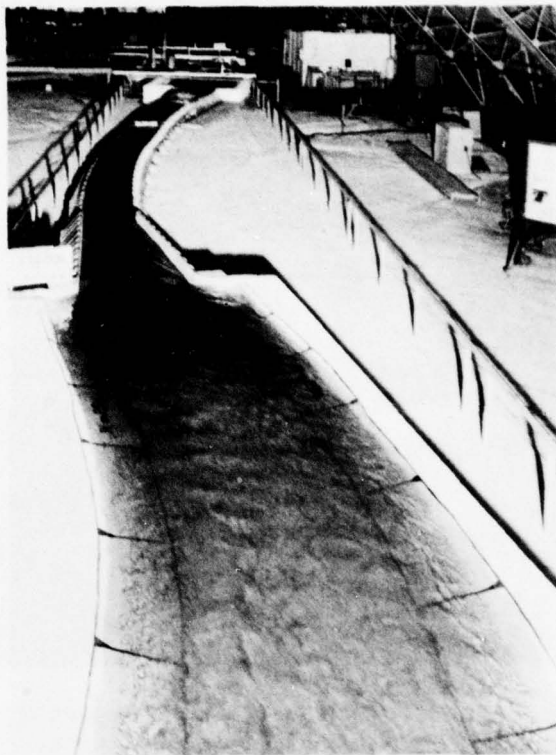
Photo 11. Overall view of
model (Bucana Channel, orig-
inal design); design flow
28,900 cfs

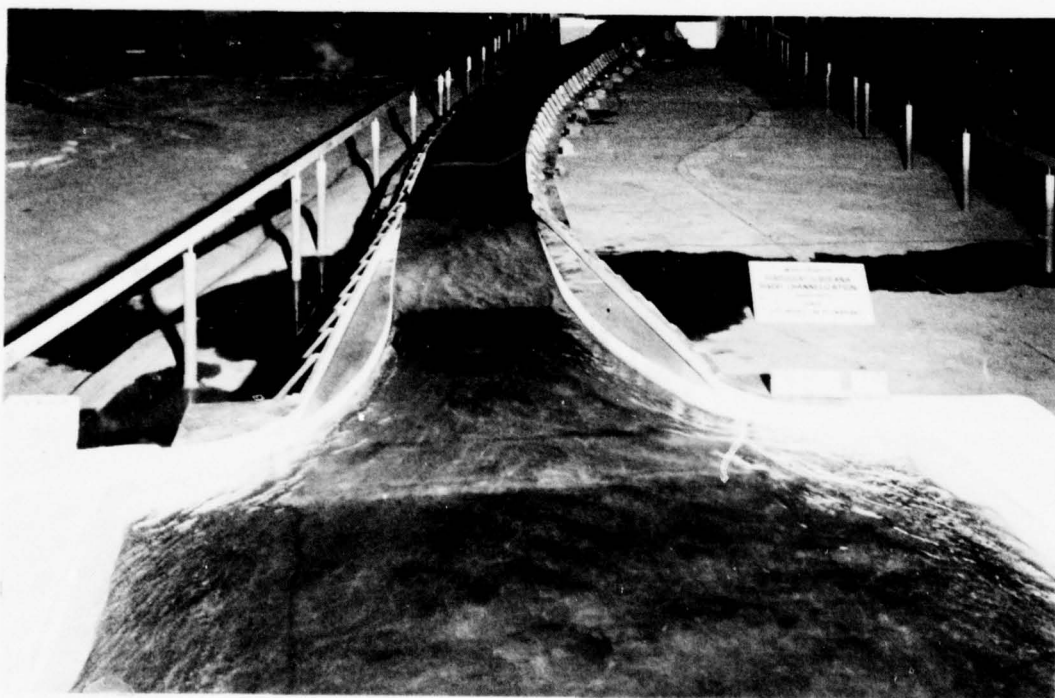
Photo 14. Bucana Channel design 3 transition at sta 157+81; design flow 28,900 cfs, bottom slope 0.0514

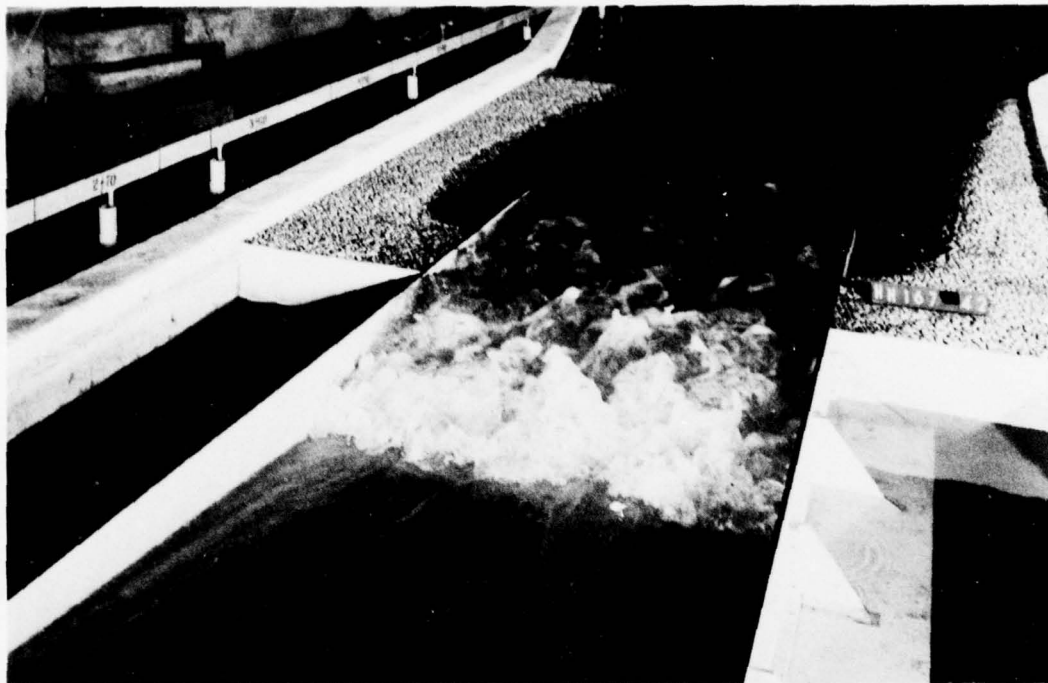
Photo 17. Stilling basin B-2 (original design); design flow 28,400 cfs, tailwater el 56.3

operating the model and Photo 17 shows the basin with the design flow of 28,400 cfs. Failure of the original design 24-in. riprap is shown in Photo 18. Lowering the end sill and exit channel as discussed in paragraph 32 prevented movement of the 24-in. riprap. A weak hydraulic jump formed in the basin, although velocities downstream were not equally distributed across the channel (Plate 31). Also, there was a considerable drawdown of the water surface immediately downstream from the end sill (Plate 32). The unequal distribution of velocities was attributed to the transition upstream between sta 188+92.8 and 187+66, and the drawdown in water surface was attributed to the high end sill.

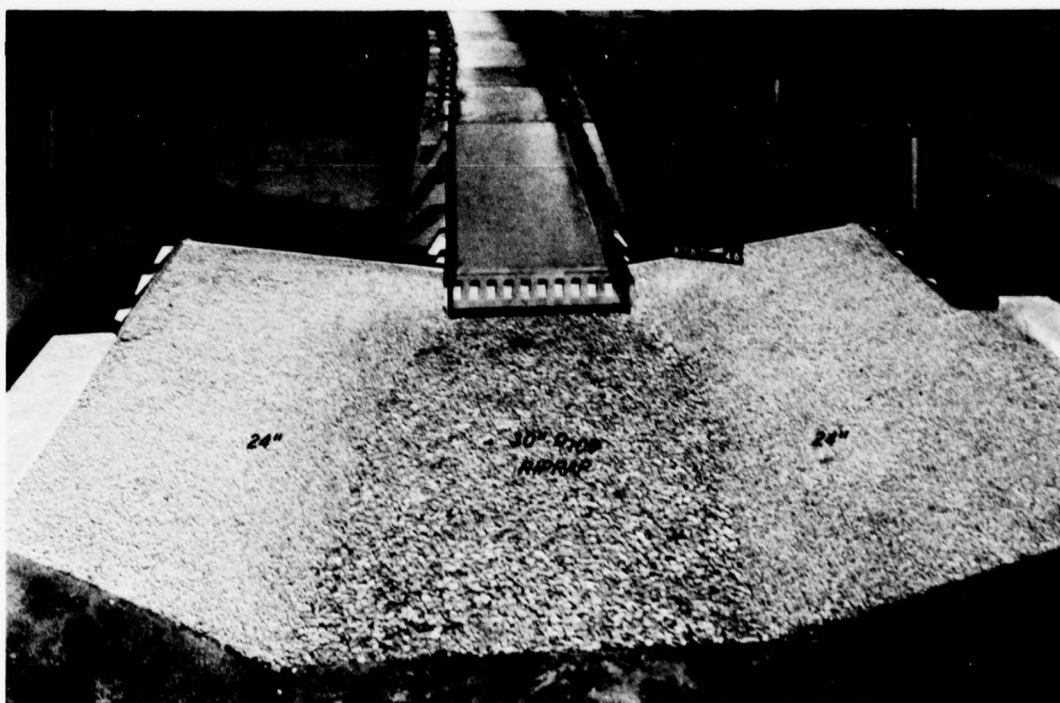
a. Looking downstream

b. Looking upstream

Photo 19. Stilling basin B-3 (original design)

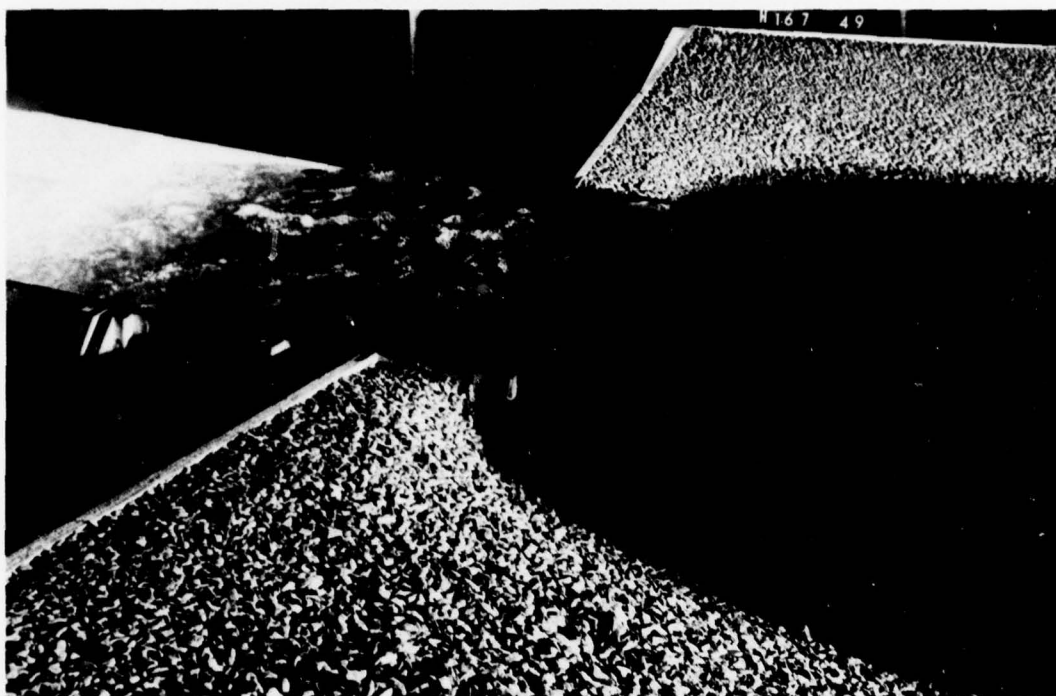
Photo 20. Stilling basin B-3 (original design); design flow 22,700 cfs, tailwater el 129.5

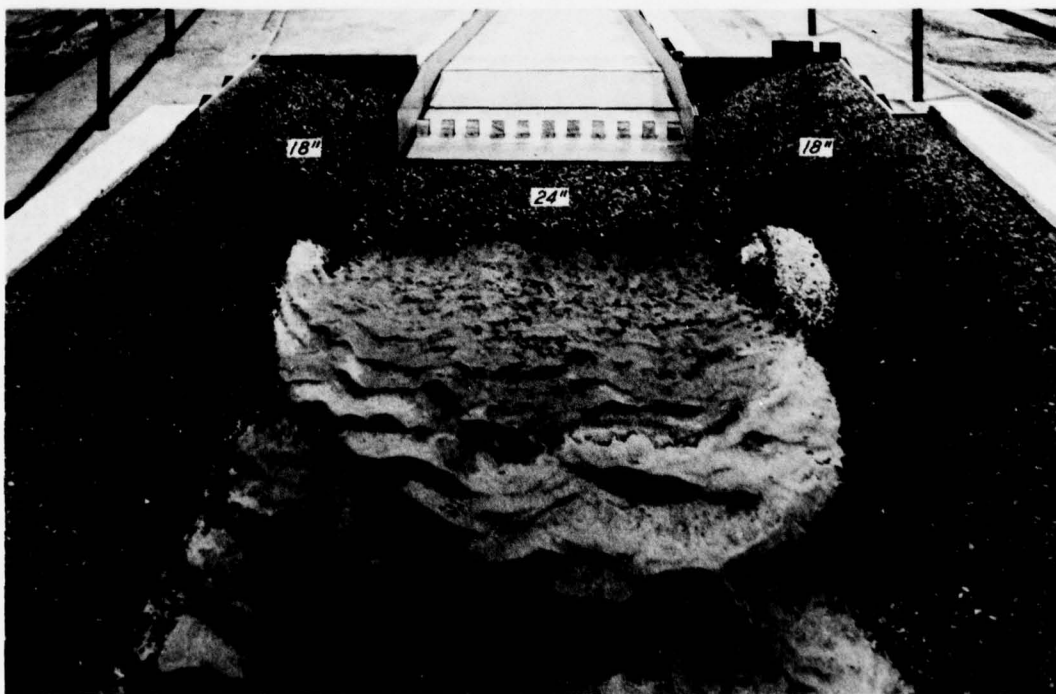
Photo 21. Stilling basin B-1 (type 5) after 1-hr (prototype) operation; type 7 riprap plan, 18-in. riprap on slopes, 24-in. riprap on bottom (el 11.5)

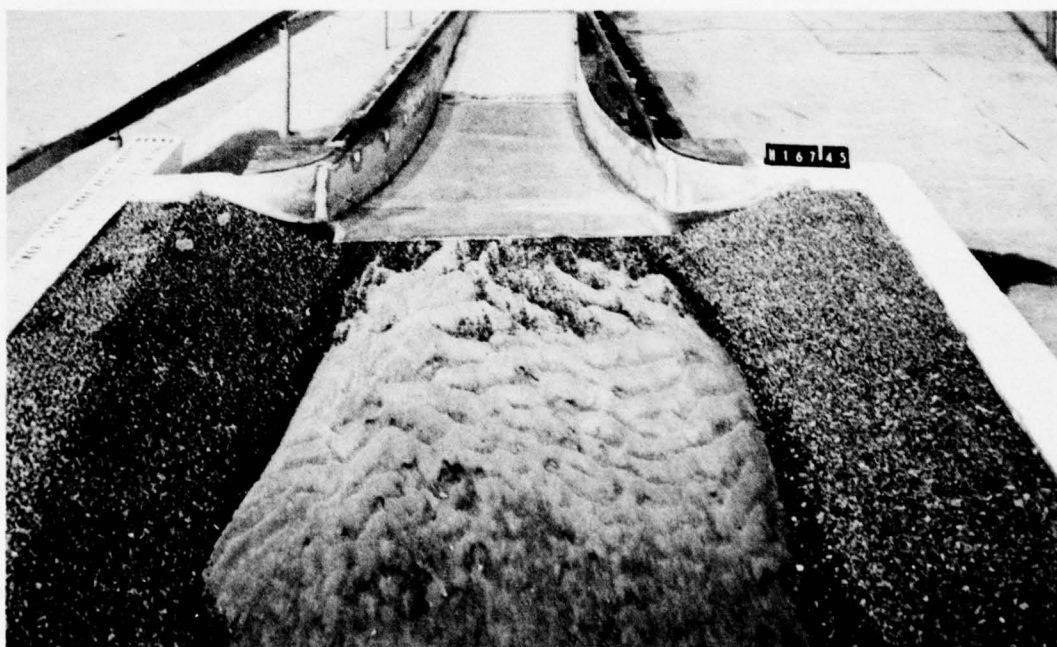
Photo 23. Original riprap plan after 30-min (prototype) operation with design flow 28,900 cfs, Bucana transition design 3

37. The original riprap protection upstream of transition design 3 (Plate 44 and Photo 22) was exposed to the design flow for 2 hr (prototype), causing some movement of the sand bottom and loose stone without actual failure or damage to the 18-in. riprap bottom or slopes (Photo 23). The original riprap protection plan (Plate 44) withstood 9-hr additional exposure with 28,900 cfs without damage and is therefore recommended for the prototype.
